Engineering Study and Evaluation For the Rehabilitation of Curtis Pond Dam

Prepared for the
**The Curtis Pond Dam Committee
Town of Calais, VT 05648**

**DuBois
& King inc.**

January 30, 2004

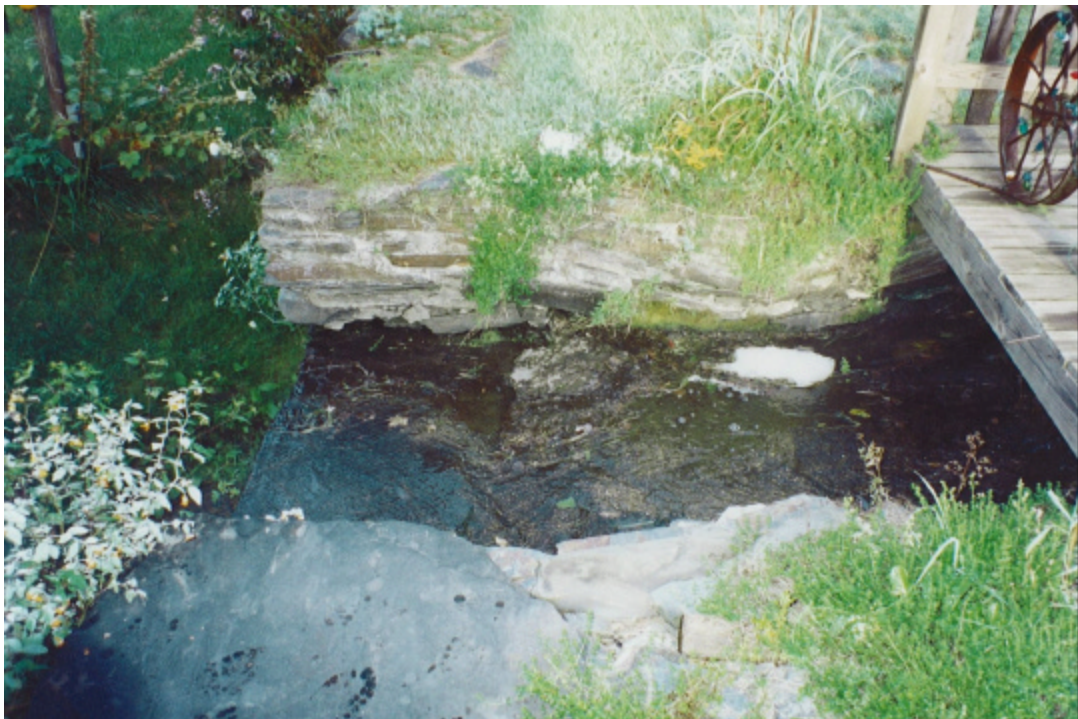
View of the spillway channel and pedestrian bridge.

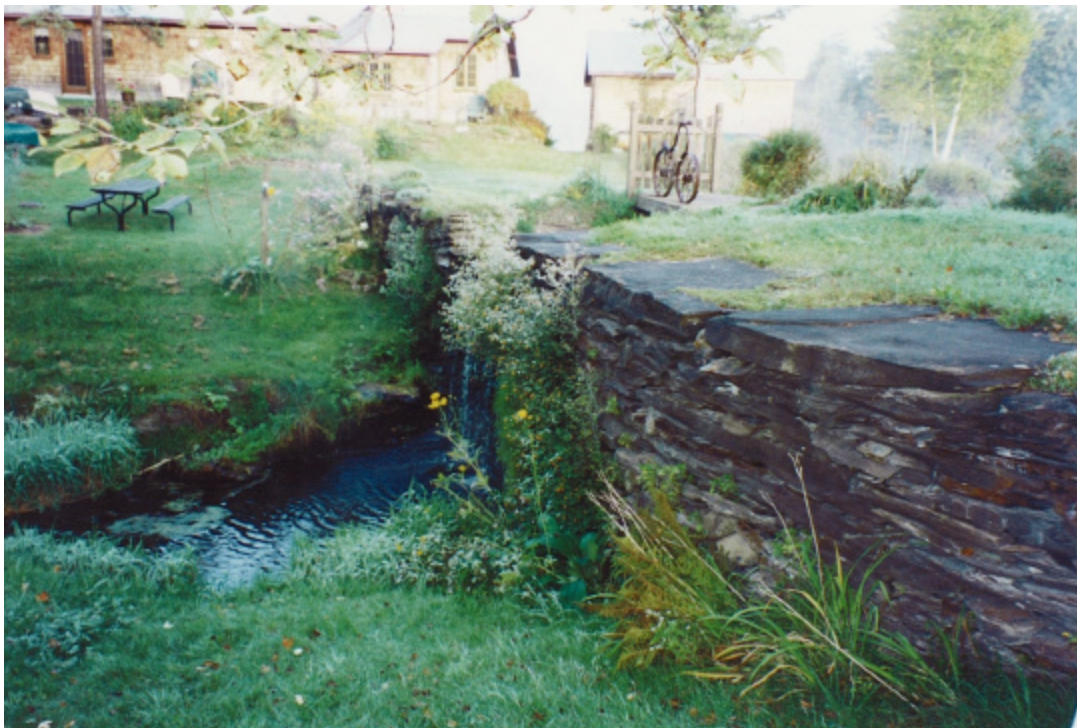
The existing Curtis Pond Dam has been and continues to deteriorate. It is considered to be in poor condition for a number of reasons, including movement of the stones, excessive seepage, piping and active sinkholes, inadequate hydraulic capacity and a inoperable low level drain.

View looking along the dam. Note the slight lean of the downstream face.

DuBois & King Inc. recommends construction of a new concrete dam wall to be installed along the upstream edge of the existing dam. This alternative meets the goals and objectives of creating a safe, low cost and low maintenance dam.
