STATE OF VERMONT Division for Historic Preservation  VERMONT ARCHITECTURAL RESOURCE INVENTORY  Individual Property Survey Form	SURVEY NUMBER: (Assigned by VDHP)
	Listed in State Register <input type="checkbox"/> Eligible for State Register Yes <input type="checkbox"/> -or- No <input type="checkbox"/> Date:
	PRESENT FORMAL NAME: Curtis Pond Dam
	ORIGINAL FORMAL NAME:
COUNTY: Washington	PRESENT USE: Dam
TOWN: Calais	ORIGINAL USE: Dam
ADDRESS: Outlet stream to Curtis Pond	ARCHITECT/ENGINEER:
COMMON NAME: Curtis Pond Dam	BUILDER/CONTRACTOR:
PROPERTY TYPE: Structure	DATE BUILT: First built c. 1813
OWNER: Undetermined ADDRESS:	
ACCESSIBILITY TO PUBLIC: Yes <input type="checkbox"/> No <input type="checkbox"/> Restricted <input checked="" type="checkbox"/>	PHYSICAL CONDITION OF STRUCTURE: Good <input type="checkbox"/> Fair <input type="checkbox"/> Poor <input checked="" type="checkbox"/>
	STYLE: Stone masonry and earth fill gravity dam

<p><b>REFERENCE CITATIONS:</b> see references in "Historic Resource Review and Archaeological Resources Assessment, Curtis Pond Dam (Vt State Id #40.09) Rehabilitation Project, Calais, Washington County, Vermont," UVM CAP Report No. 1509.</p>
<p><b>SURROUND

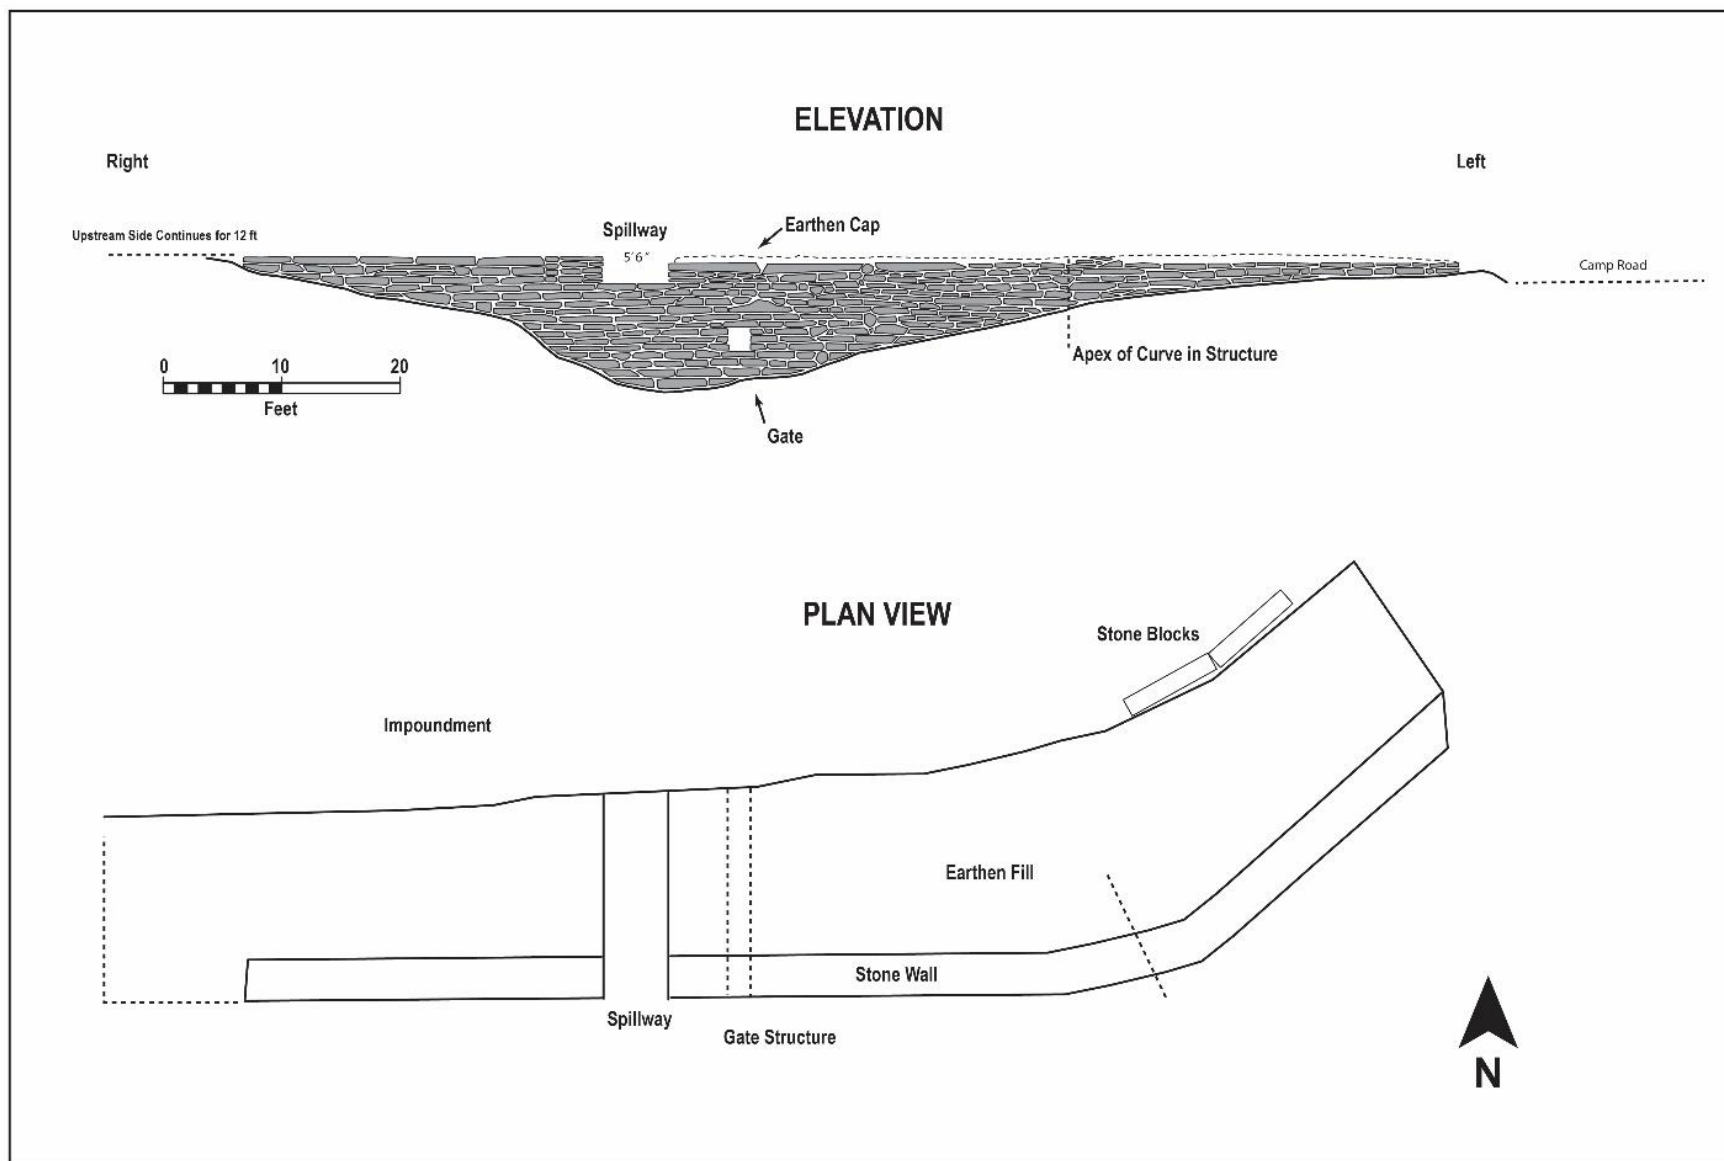
Elevation and plan view of the Curtis Pond Dam.

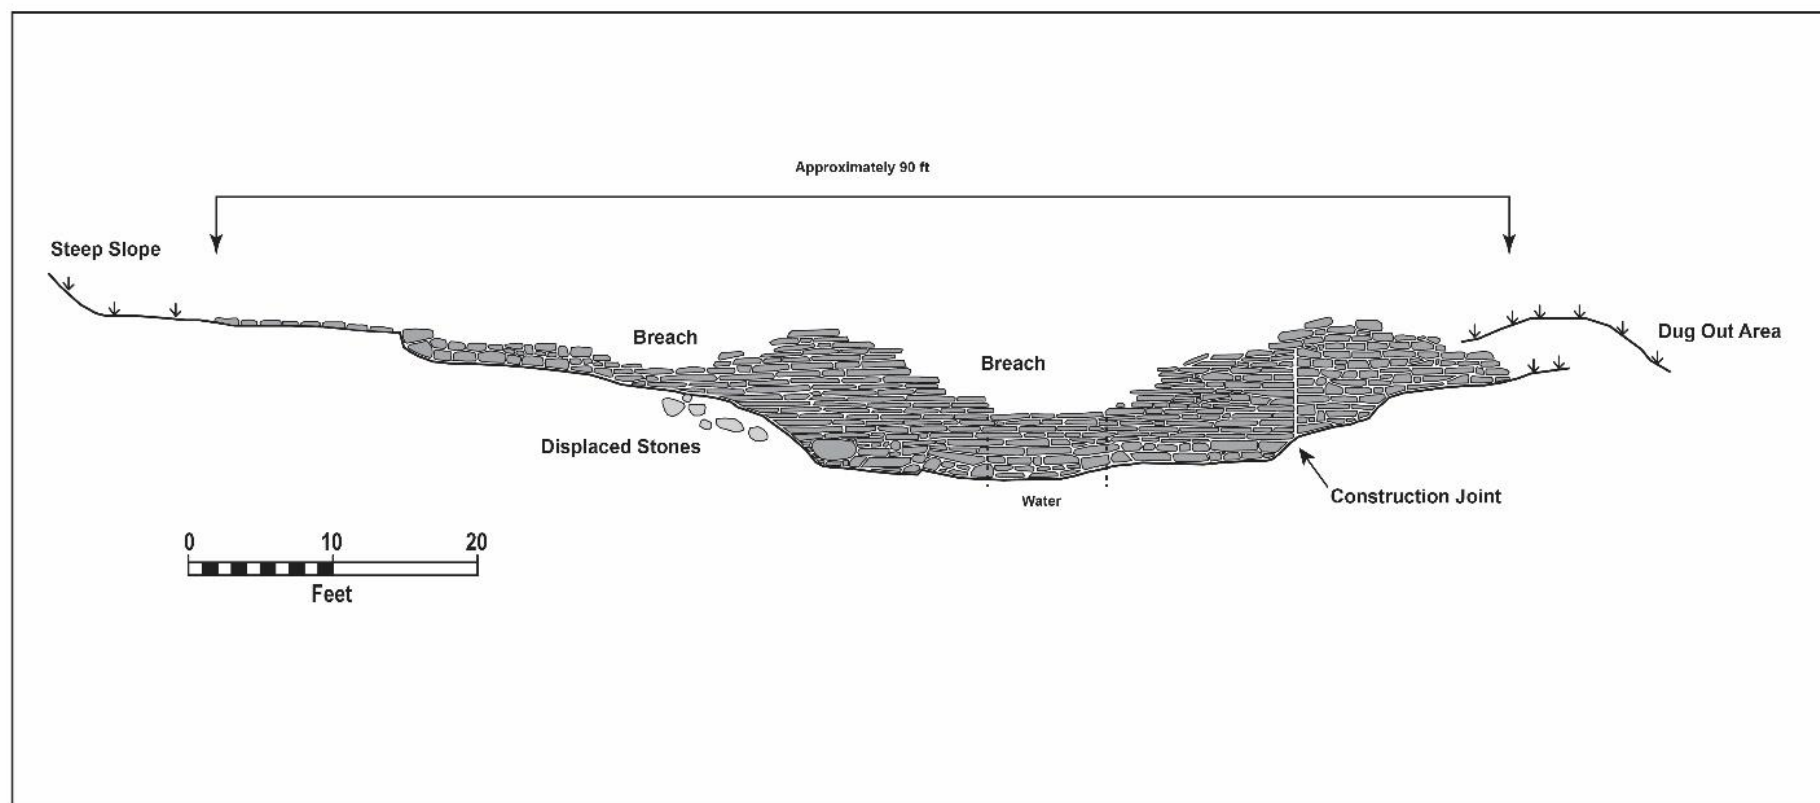
Downstream sketch elevation of the Maple Corner Dam.

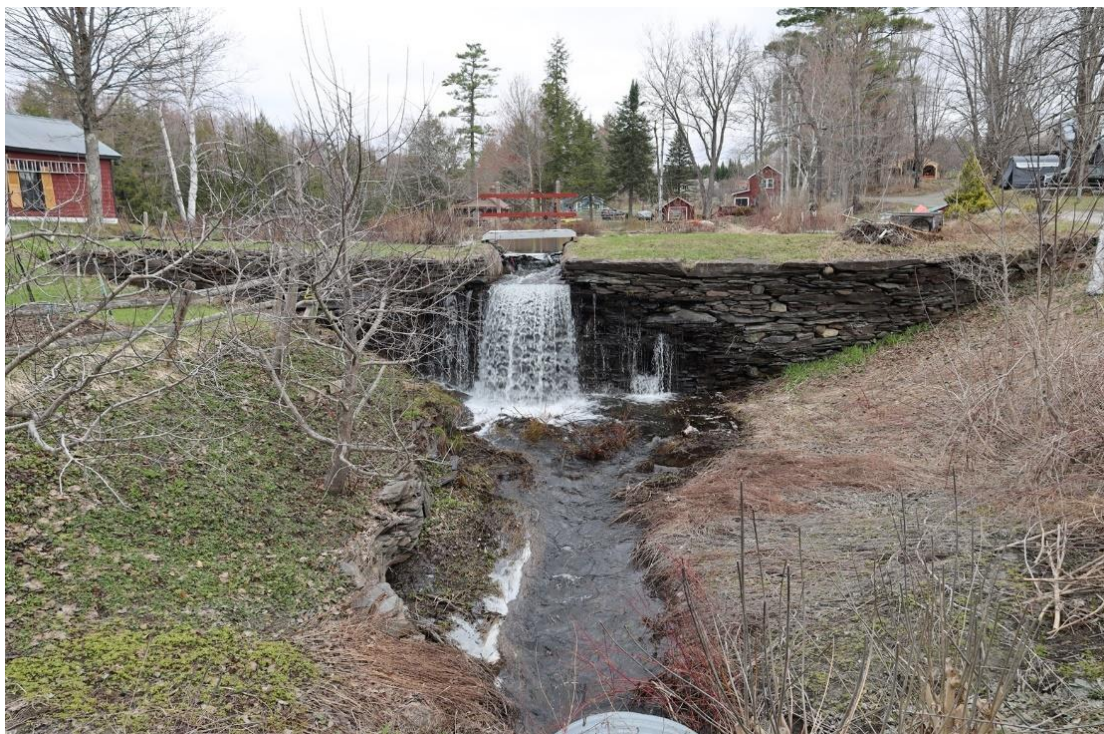
View of the Curtis Pond Dam looking north from Worcester Road.

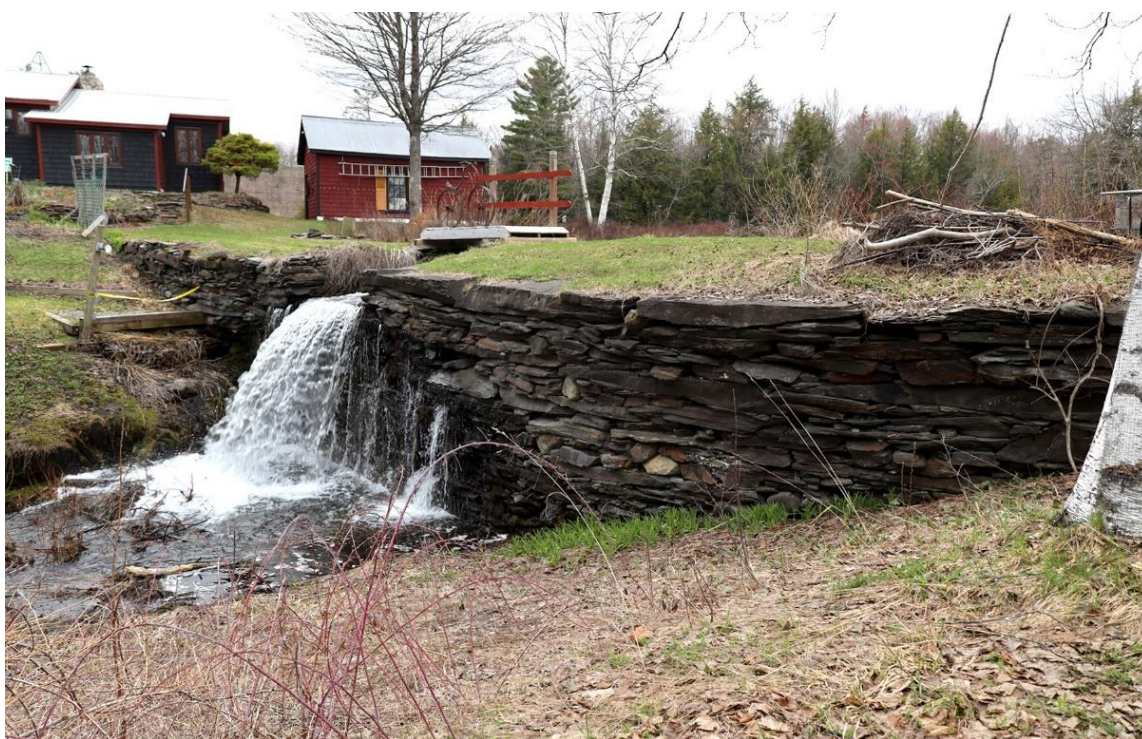
View northwest of the Curtis Pond Dam.

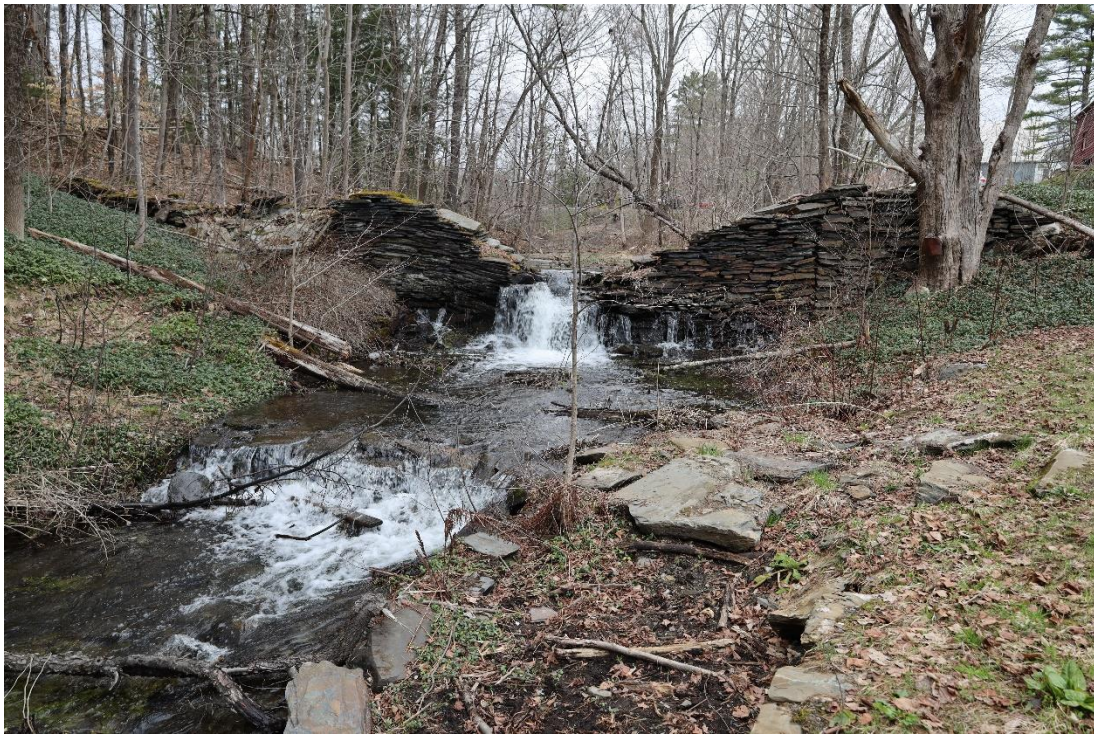
View of the Maple Corner Dam looking north.

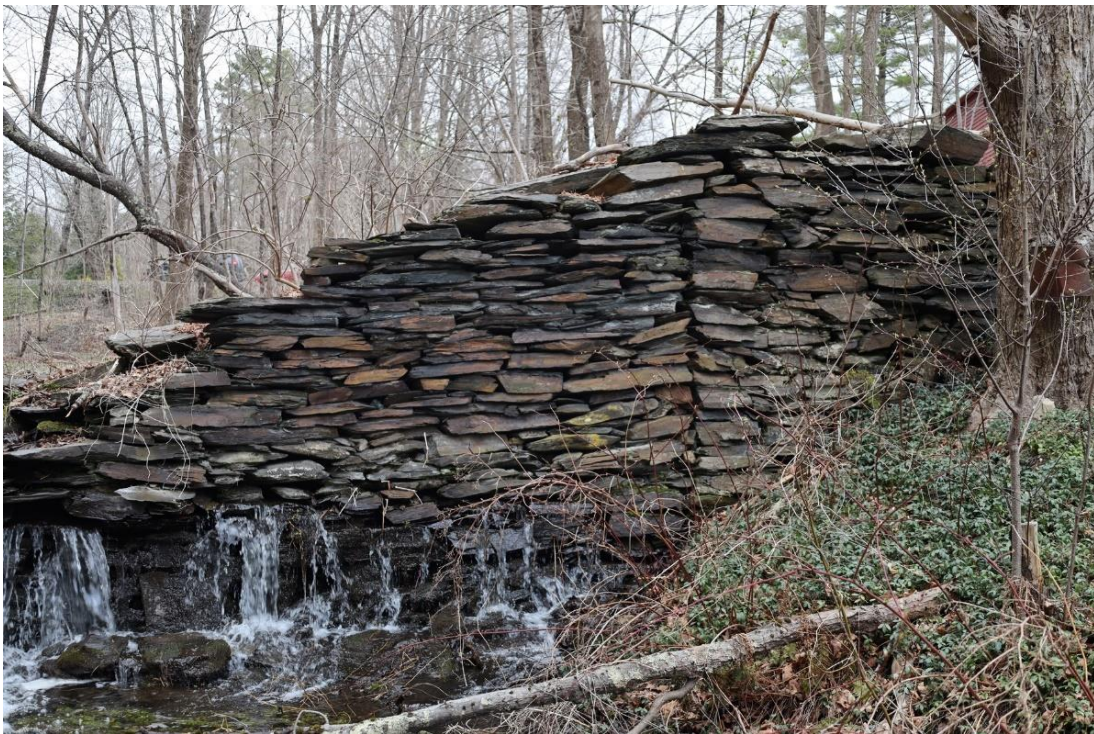
View north of the downstream side of the Maple Corner Dam showing a large construction joint, possibly marking the division between a foundation (right) and the dam (left).
