CURTIS POND WATERSHED SURVEY

FALL 2003

**Conducted by volunteers under the guidance of
the Lakes and Ponds Working Group of The Calais Conservation Commission and
the VT Department of Environmental Conservation, Lakes and Ponds Section**

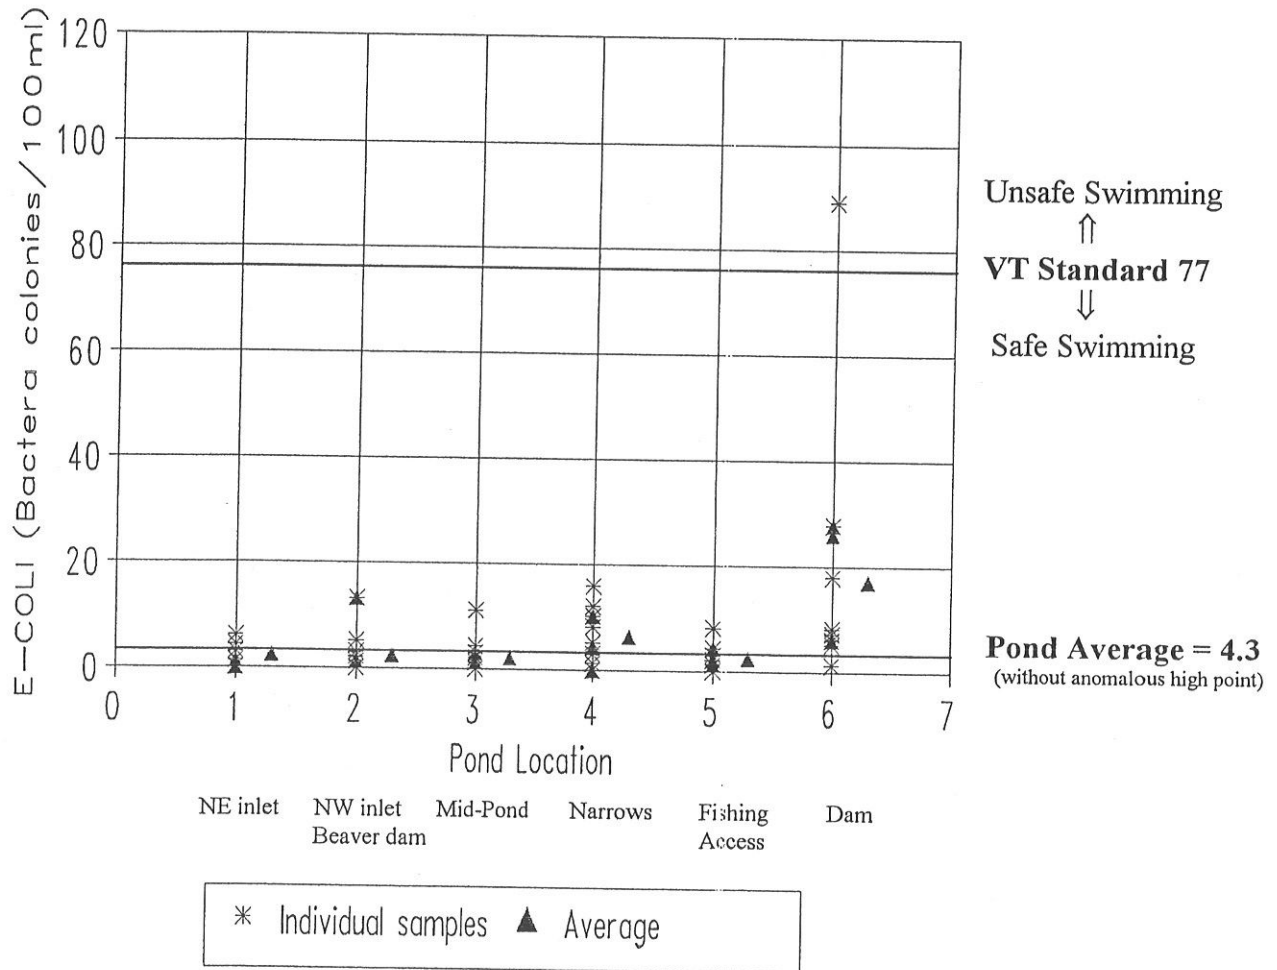
MAP 4

The results of the testing thus far show that *E. coli* levels in Curtis Pond are very low and swimming is safe (See MAP 4). The average result for the pond was 4.3 bacteria colonies/100 ml. Only one sample, taken from the cove near the dam, exceeded the state standard of 77. It is noted that there are two areas of the pond where the *E. coli* levels were somewhat higher than the rest of the pond. These areas are the cove near the dam (Location 6), which averaged 10.6, excluding the single high result of 89, and the shallow area of the pond just north of the narrows (Location 4), which averaged 6.2. These are still low numbers. The rest of the pond averaged 2.3 colonies of *E. coli*/100 ml. It is interesting to observe that the presence of *E. coli* in 2003 was lower than the previous two years. For 2001 and 2002 the pond average was 5.6 colonies/100ml. For 2003 the pond average was 2.4 colonies/ml. Further observations are needed to determine if this is a trend or just a temporary decrease.

Results of E-COLI Testing

Curtis Pond Summers 2001-2003

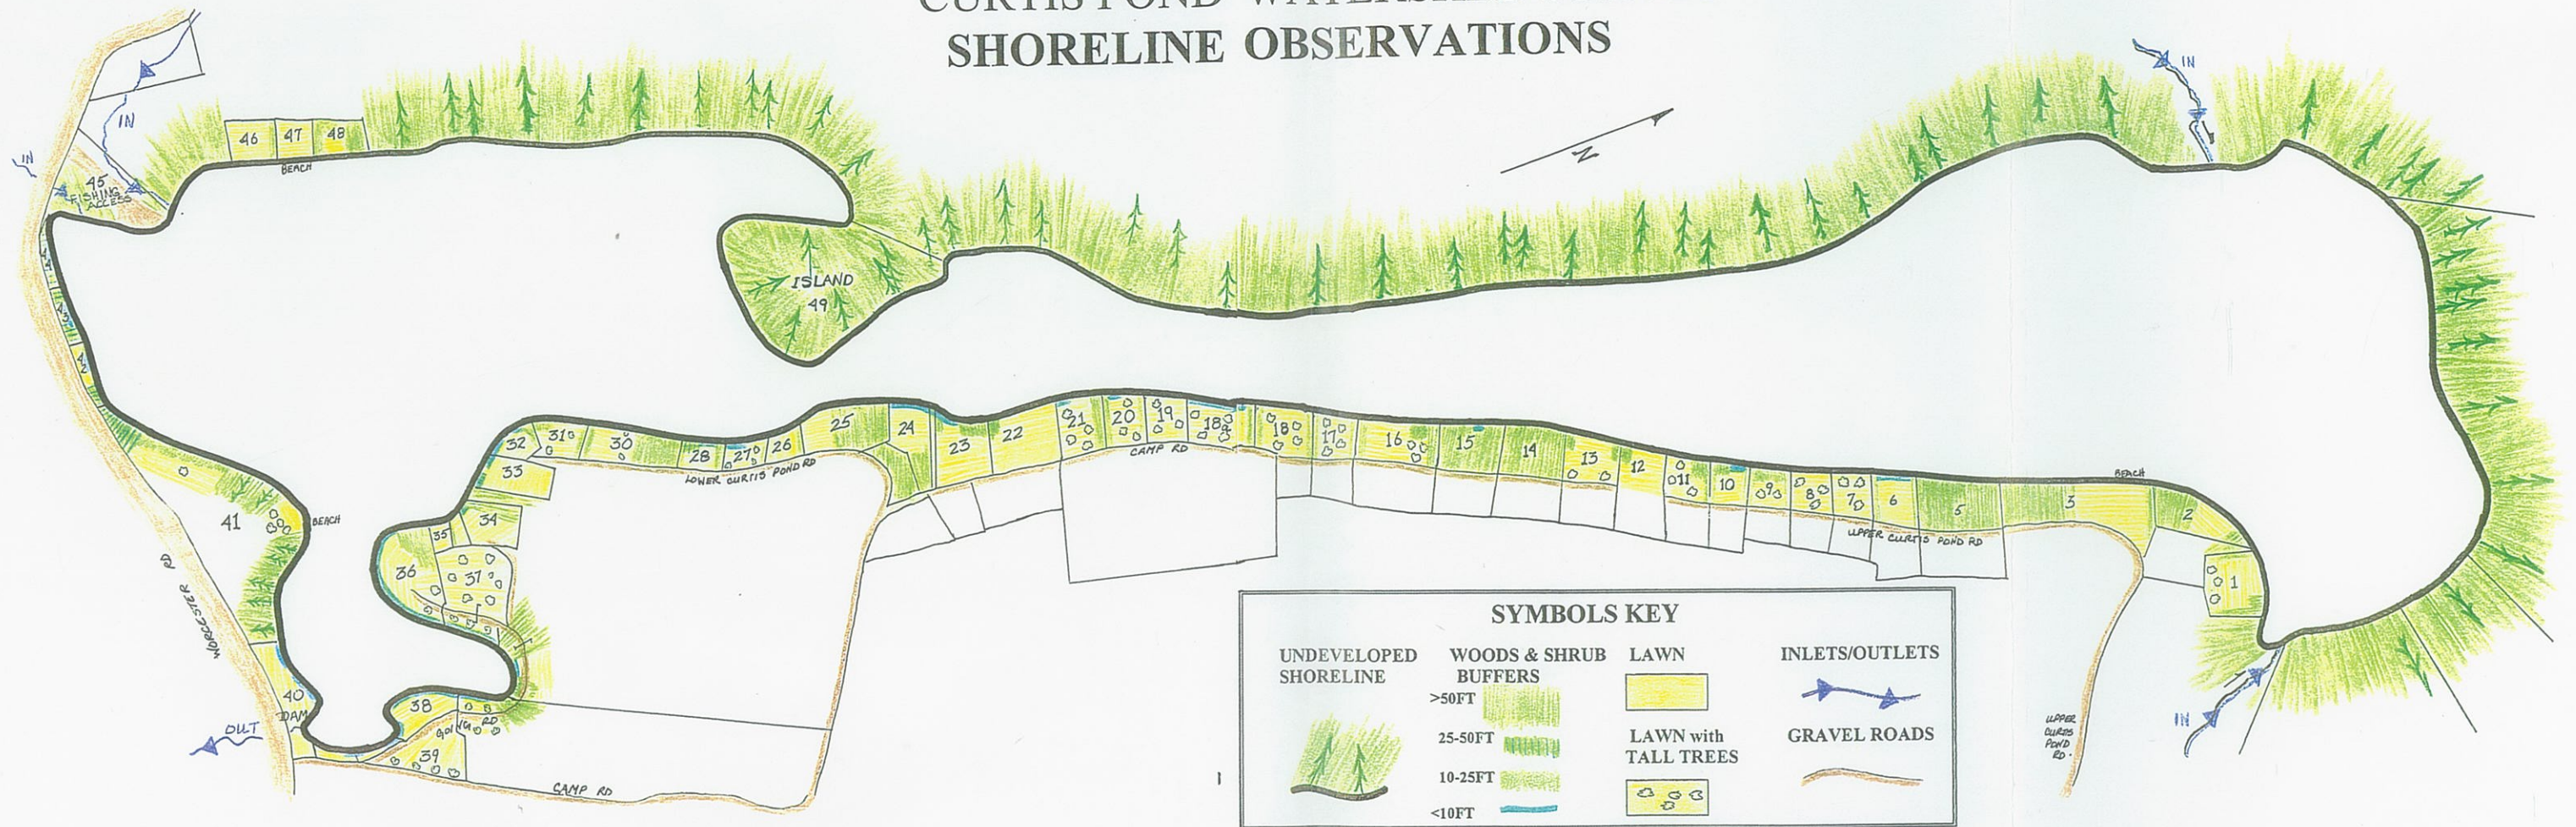
MAP 5

Summary observations are listed below. A map follows which shows the composition of the shoreline and the relative amounts of natural buffer (i.e. woods,

shrubs and wetlands) versus cleared areas (i.e. lawns and beaches) (MAP 5). Appendix C provides detailed observations for each of the parcels including a photograph of the shoreline taken in summer 2003. It is hoped that these will be a useful historical reference for the future.

- As stated earlier, 70% of the shoreline is undeveloped. Nearly all of the western and northern shorelines are undeveloped. They account for ~49% of the shoreline. Large stands of woods and wetlands make up the preponderance of the land at the Town Swimming Access and the VT State Fishing Access (~8% of the shoreline). The rest of the shoreline is privately owned and divided into lots for camps and houses. Many of these lots have large areas of undeveloped woods and wetlands. Even the smaller lots typically have a barrier of woods that separates them from their neighbors. In total, there are approximately 2000FT (~13% of the shoreline) of undeveloped lands within the residential properties.

- Narrower buffers are present on some of the properties. A woody/shrubby buffer of 10 – 50ft exists for approximately 500FT (3%) of the shoreline. Most of this buffer is less than 25ft deep. Approximately 1600FT (11%) of shoreline have a buffer of less than 10ft.

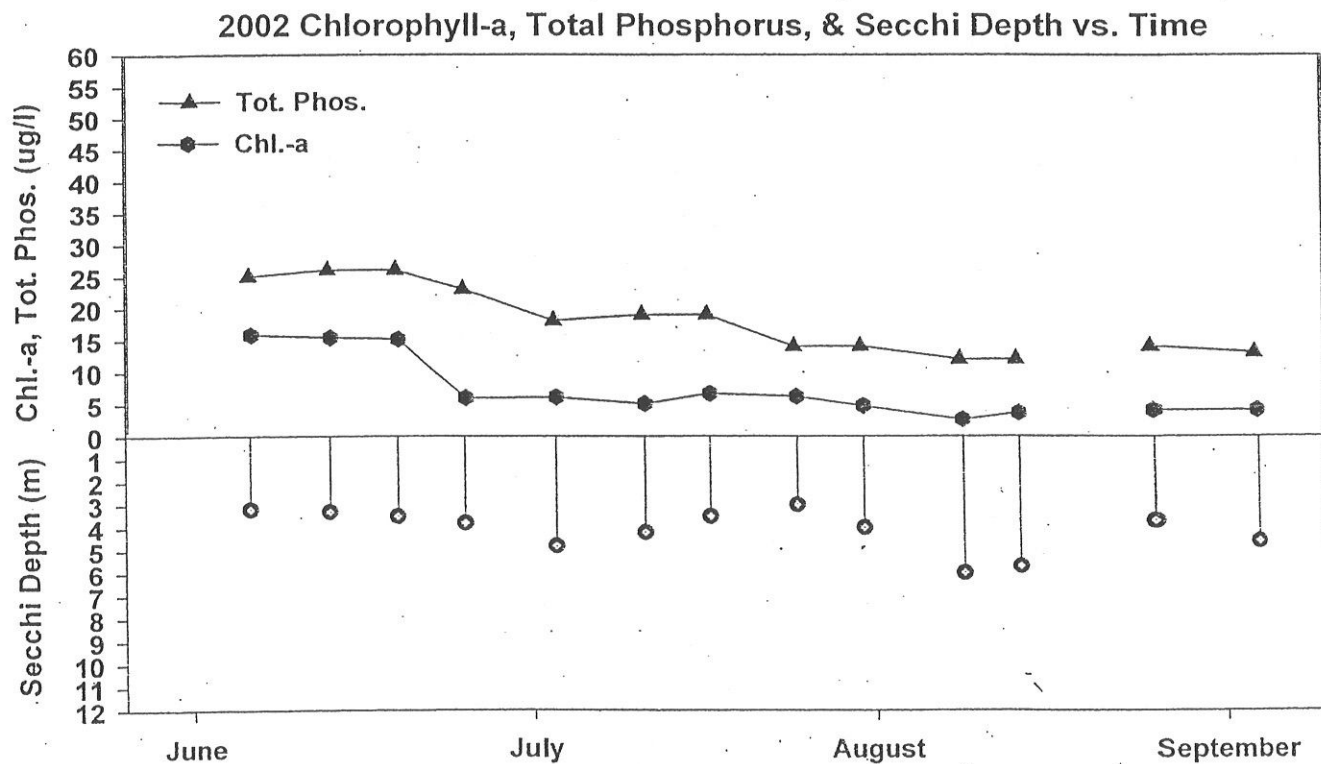
Curtis Pond

Water clarity - moderate
Algal population density - moderate
Nutrient enrichment - high

Trophic State: Eutrophic

Year	Days Sampled	Secchi (m)	Chloro-a (ug/l)	Summer TP (ug/l)	Spring TP (ug/l)
1994	12	4.0	5.1	12	
1995	10	4.7	4.5	11	11.1
1996	12	4.6	6.9	12	
1997	12	4.4			
1998	12	3.6	10	19	
1999	10	4.7	11	15	18.4
2000	11	4.3	9.0	18	
2001	14	3.8	9.2	22	24
2002	13	4.1	6.7	18

AVG(m) 4.24 61% INCREASE 57% INCREASE
AVG(ug/l) 13.8
