# DAM HAZARD CLASS ASSESSMENT REPORT

**Carlton Reservoir Dam, Curtis Pond Dam, Kenny Pond Dam, and Southern Vermont Orchard Dam**

**Vermont Department of Environmental Conservation  
Washington County, Vermont**

Schnabel Reference 19C25003.00

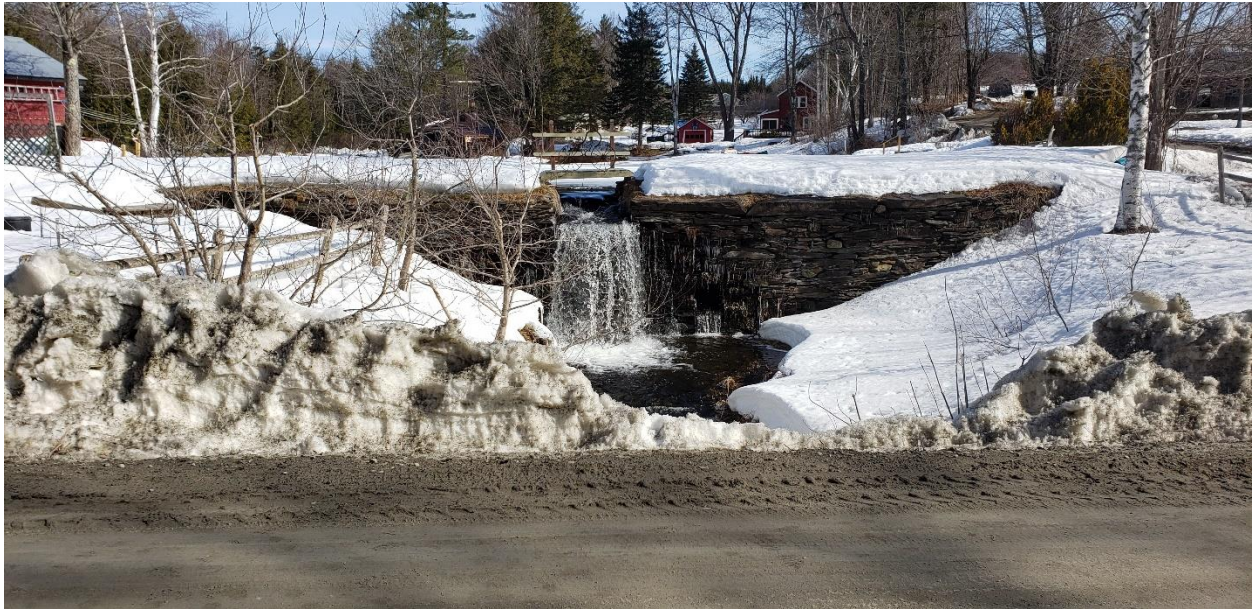
Figure 2.14 – View of Dam and Spillway from Downstream Side

Based on the information provided from VT DEC and the field measurements performed by Schnabel, the spillway has a crest elevation of approximately 1217.8 and is approximately 5-ft in length. Based on the DEM data, the crest of the dam has a minimum elevation of approximately EL 1219.3, providing an effective weir head of approximately 1.5-ft before the dam would overtop. The spillway was represented in the HEC-HMS hydrologic model and HEC-RAS hydraulic model with a weir coefficient of 2.65. A photograph of the dam and spillway is presented in Figure 2.14 below.

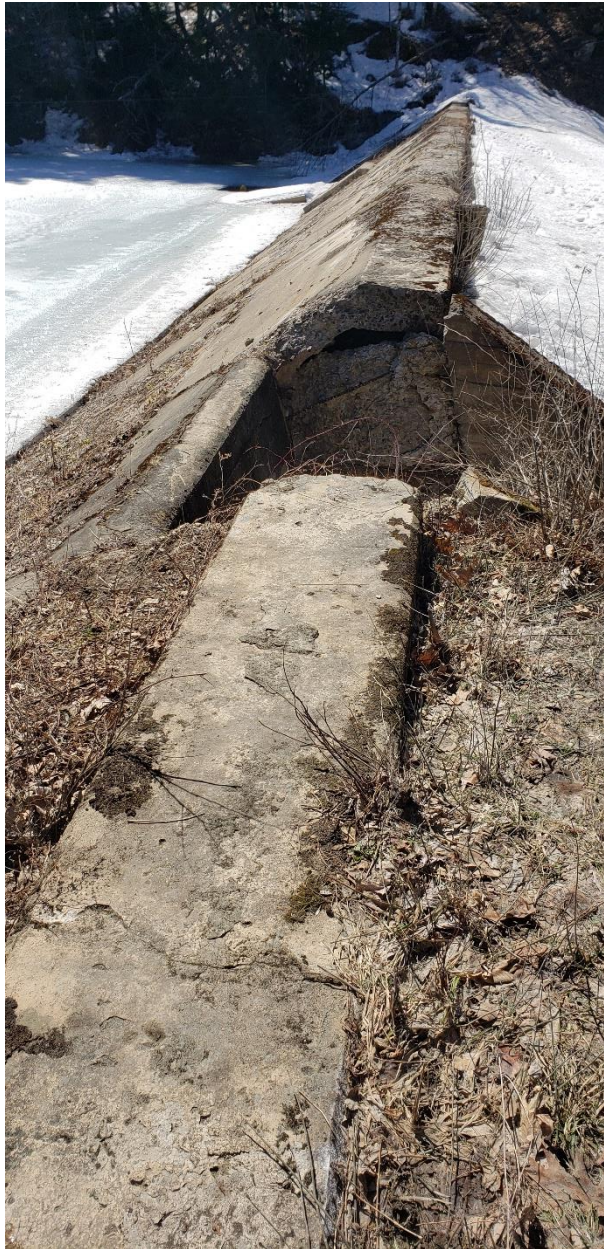
**Figure 2.15 – View of Dam and Spillway from Right Abutment**

The principal spillway at Carlton Reservoir is reportedly an 8-inch diameter drop inlet with a crest elevation of EL.1053.7. The auxiliary spillway was assumed to have a crest elevation of 1062.7 based on field measurement from normal pool to spillway crest and is approximately 10-ft in length. The elevation difference between the auxiliary spillway crest and the top of the dam is approximately 2 ft. A weir coefficient of 3.3 was used for the auxiliary spillway and the primary spillway was modeled as a culvert outlet. A photograph of the dam and spillways are presented in Figure 2.15 below.

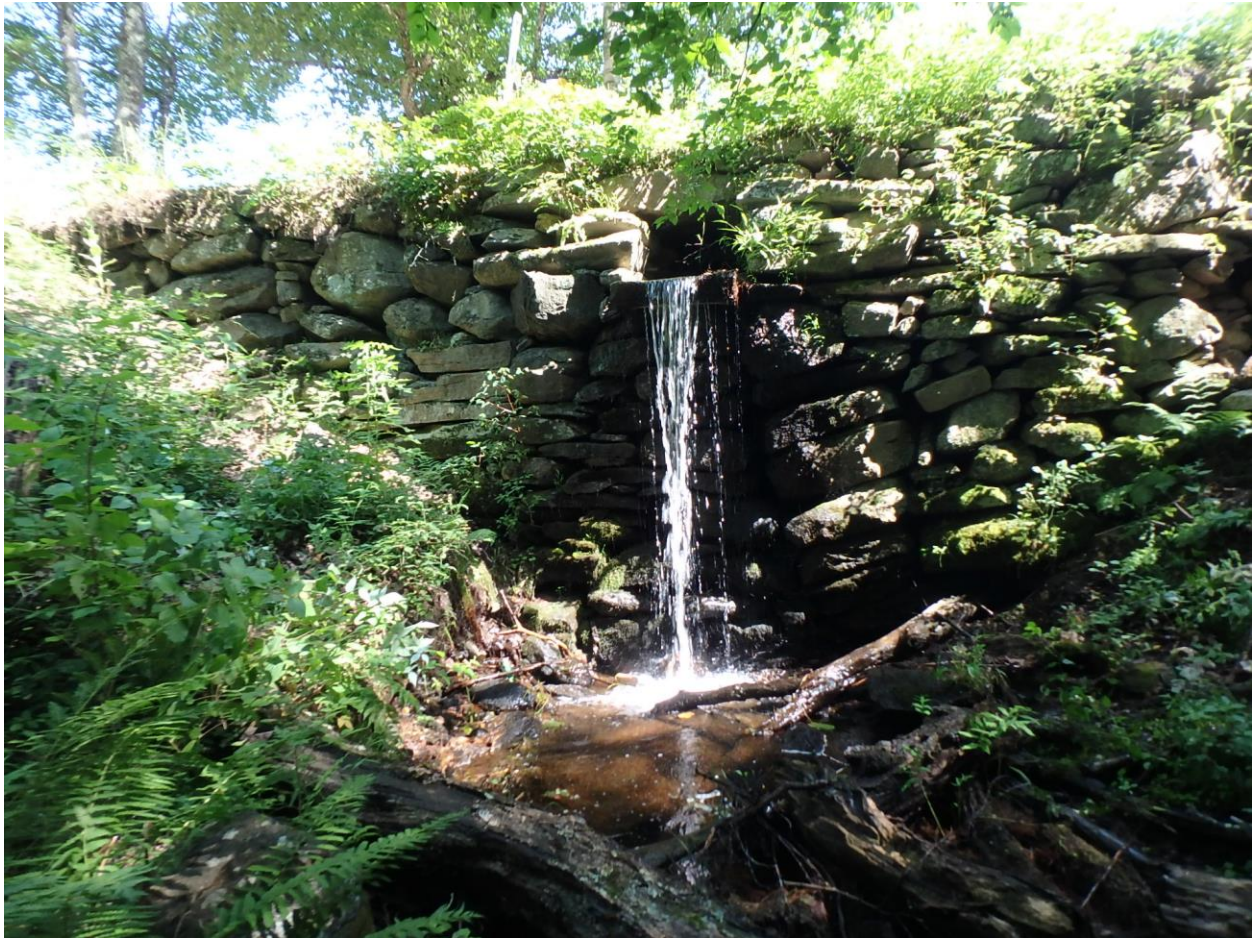
**Figure 2.16 – View of Dam and Spillway from Downstream Side**

Due to snow cover and road closures, Schnabel was unable to perform a field visit at Kenny Dam itself but was able to observe the downstream drainageway. However, photographs of the Dam were provided by VT DEC. Based on the information provided, the principal spillway starts with a stone masonry approach channel and transitions to a 2.6-ft x 1.8-ft stone-lined culvert beneath Newfane Hill Rd, which traverses the dam crest. Based on the DEM, the upstream end of the spillway culvert was assumed to be at EL 1249.0. A photograph of the dam and spillway is presented in Figure 2.16 below.

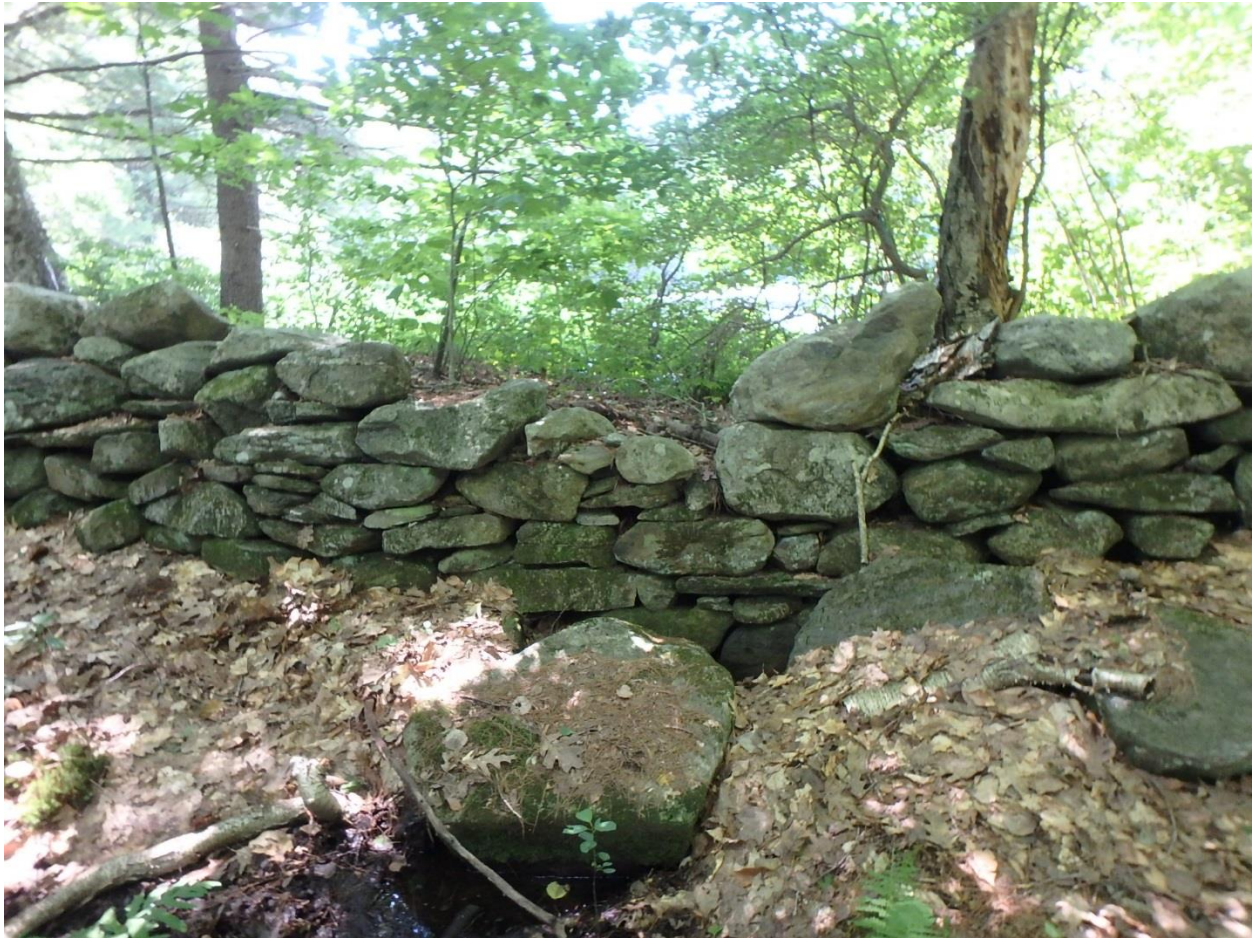
Figure 2.17 – View of Auxiliary Dike

Previous inspection reports also noted a remote auxiliary spillway/dike located at the northeast end of the reservoir. The dike is reported to be a laid-stone and earthen embankment with heights up to approximately 4 ft. Vermont DEC provided photos of this auxiliary structure and collected field measurements to estimate the crest elevation of the structure. Based on this data, the low point along the dike is at approximately EL 1250.7 with the majority of the structure above EL 1252, which is close to the crest elevation of the main dam. A picture of a portion of this auxiliary dike is presented in Figure 2.17.

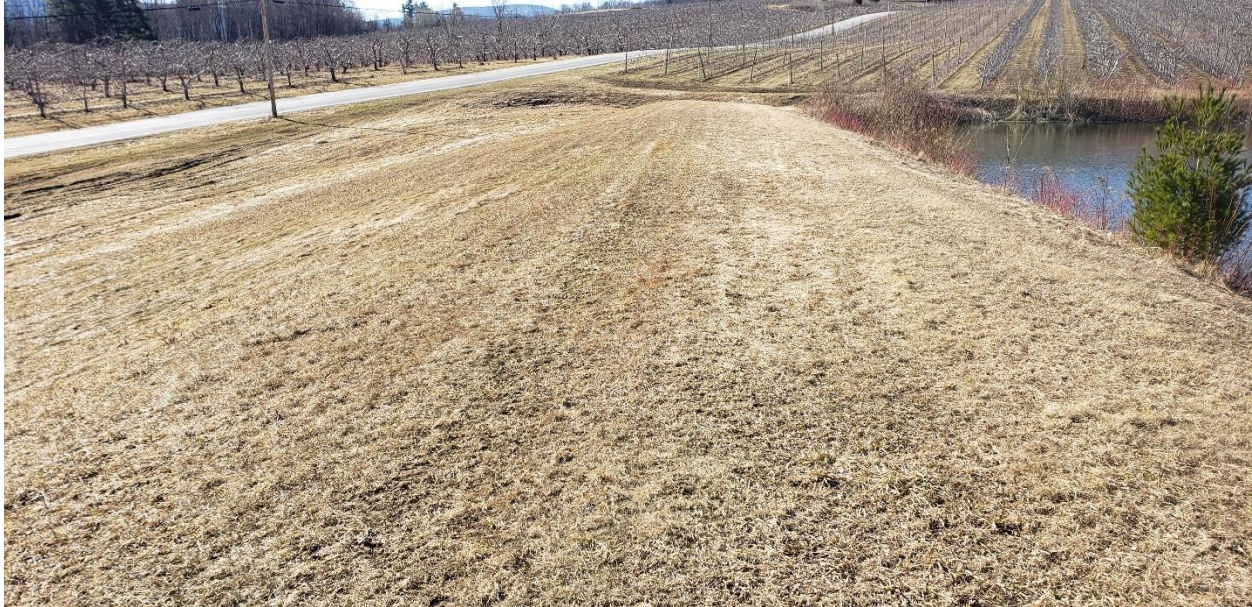
**Figure 2.18 – View of Dam and Spillway from Left Abutment**

Based on the information provided and the field survey performed by Schnabel, the principal spillway is a 30-in CMP riser connected to a 24-inch CMP outlet pipe. The first auxiliary spillway at the left abutment has an average crest elevation of 1075.7 and the second auxiliary spillway at the right abutment has an average crest elevation of 1075.0. Each earthen auxiliary spillway sections have a bottom width of approximately 30-ft in length with side slopes at approximately 5H:1V. The auxiliary spillways were represented in the HEC-HMS model with a weir coefficient of 2.6. A photograph of the dam and right auxiliary spillway is presented in Figure 2.18 below.
